U.S. Department
of Transportation
**Federal Aviation
Administration**

General Aviation Airworthiness Alerts

AC No. 43-16

**ALERT NO. 233
DECEMBER 1997**

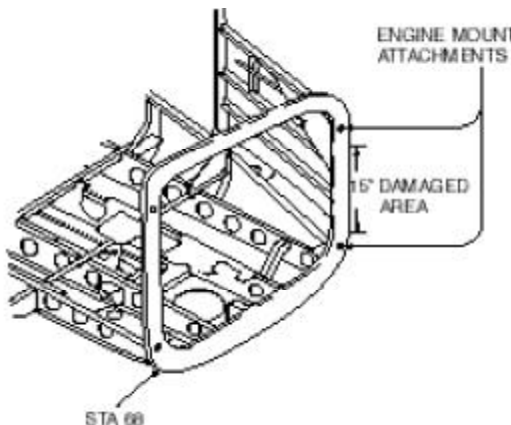
During a scheduled inspection, severe corrosion was found on a fuselage structural frame at fuselage station 68.

The corrosion had consumed an area approximately 15-inches long on the left side of the frame (P/N 169-400025-61 which was superseded by P/N 169-400025-11) where it contacted a cabin inlet fresh air "scat" tube (P/N 111728-808-23). The damaged area was located between the upper left and lower left engine mount attachment points. The corrosion had completely penetrated the material thickness. (Refer to the following illustration.) Several other more isolated corrosion sites were found at other locations on the frame. It appeared the corroded areas coincided with places where the "scat" tubing contacted the metal frame. The submitter suggested this area be closely checked during each scheduled inspection. The "scat" tube should be repositioned to provide clearance from the frame.

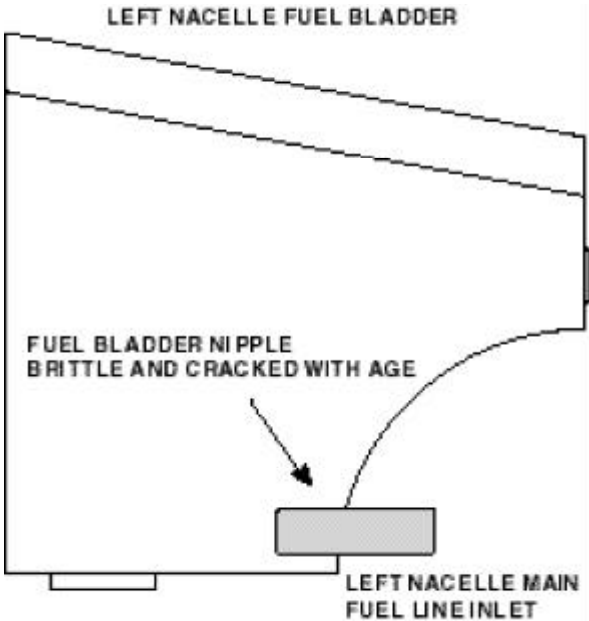
After returning from a flight, the pilot reported a massive fuel leak just prior to engine shutdown. The fuel shutoff valves were set to the “off” position with no effect.

An investigation disclosed the left main fuel cell nipple had become brittle and was severely cracked. (Refer to the following illustration.) This aircraft was manufactured in 1977, and the bladder fuel cell (P/N 92-920020-3) in the nacelle was believed to be original equipment. Through research of this problem, it was learned that the manufacturer had changed the composition of the nipple material after 1979 to improve its durability.

At this time, the manufacturer is reviewing research data and considering establishing a life limit for bladder fuel cells and their components. The present replacement requirement for the bladder cells is “on condition.” The submitter recommended that any fuel cell over 15 years old be inspected frequently and replaced when necessary.

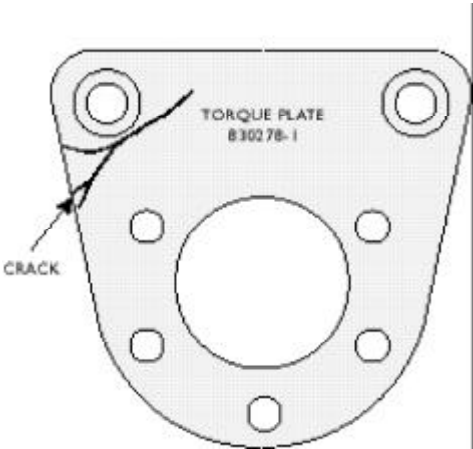
During a maintenance preflight inspection, a rub mark was observed on the inside of the left wheel brake disk.

Further investigation disclosed that the brake torque plate (P/N 830278-1) was cracked in the area of the bushing for the caliper slide pins. (Refer to the following illustration.) The submitter stated this was the second torque plate he had found to be cracked on the left wheel brake. This is an area to give special attention during scheduled inspections and maintenance.

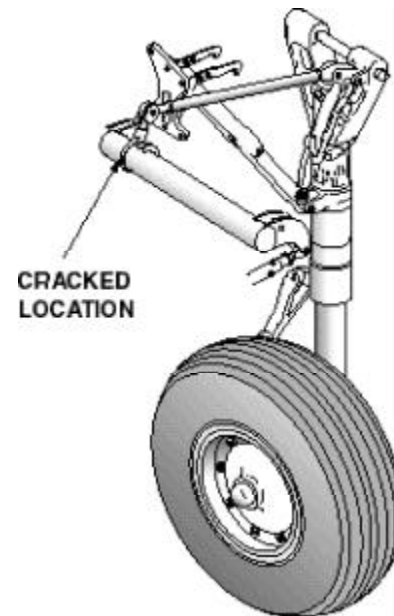
During an annual inspection, the left main landing gear door torque tube assembly was found to be cracked.

The crack was located adjacent to a weld for the fork bolt attachment fitting at the aft end of the torque tube (P/N 5045010-19). (Refer to the following illustration.) The crack was approximately .5 inch long, and the submitter stated that corrosion was present. The Service Difficulty Program data base contains 42 additional entries similar to this report. Many of those reports related more severe failures which resulted in substantial aircraft damage and/or personal injuries. Also, this torque tube is used on several other Cessna aircraft models. Airworthiness Directive (AD) 76-13-07 and Cessna "Multi-Engine Service Letter" (SL) ME75-23 deal with this subject. Maintenance personnel should concentrate their attention on this area during scheduled

inspections and comply with AD 76-13-07 and SL ME75-23.

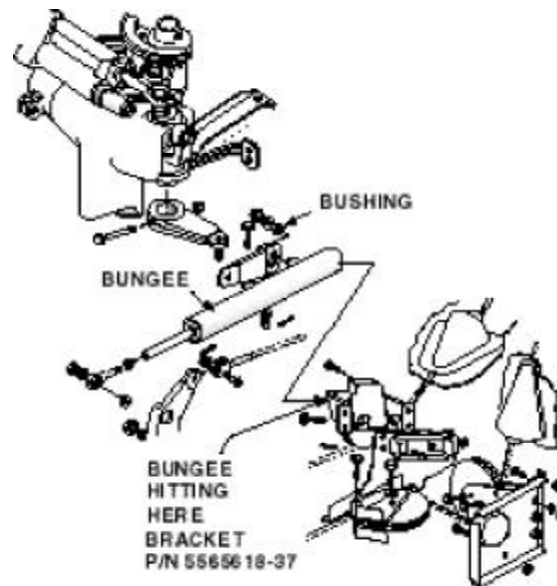
While investigating a reported abnormal noise in the nose wheel well area, a wear mark was found on a bracket.

The worn bracket (P/N 5565618-37) is mounted on the left side of the wheel well and is used to support one of the nose wheel steering cable pulleys. (Refer to the following illustration.) Also, it appeared there was an exceptional amount of "slop" associated with the steering bungee. The submitter speculated that the bracket wear allowed the bungee to drop down and bind on the pulley bracket when the nose wheel "goes full travel" to the left. If not corrected, this could cause separation of the

pulley bracket from the structure when the nose wheel is moved back to the right position.

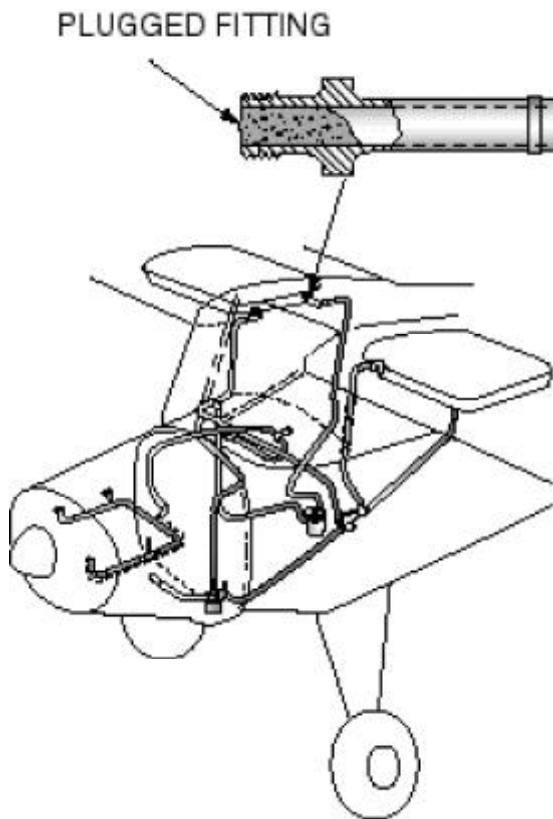
After repair of the structural and sheet metal damage, an inspection of the fuel system revealed the right fuel tank aft outlet fitting (P/N AN840-6D) was completely plugged. (Refer to the following illustration.) The material blocking the outlet fitting appeared to be tightly compacted "dirt" from an unknown source. It was speculated that over many years sediment from many gallons of fuel, "dirt," and other contaminants had collected in sufficient quantities to stop the engine fuel supply. The criteria for this aircraft accident required the right fuel tank to be selected as the sole source of engine fuel supply.

It would be wise to inspect and clean the fuel systems of older aircraft at frequent intervals to eliminate contamination which, if not removed, could result in an accident.
